CASE STUDY

TOWER VERTICALITY, SCANNING & MONITORING

Project: Tower Verticality, Monitoring & Scanning
Location: Tilbury, Essex
Year: 2019
Duration: 2 days

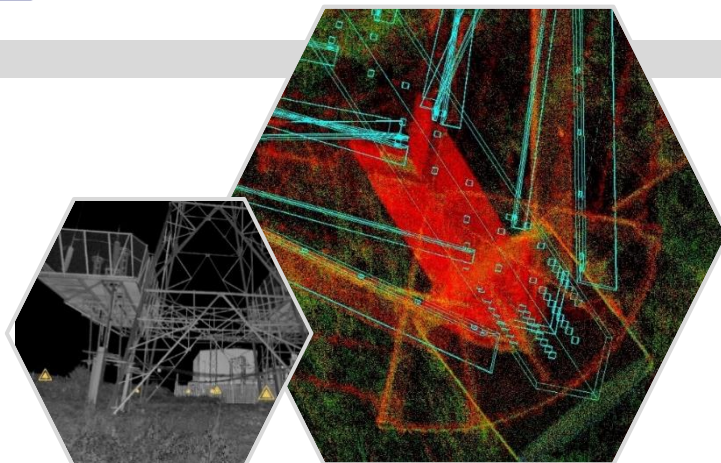
Using the survey data, we were able to extract the necessary information to prove that the tower's lean was within acceptable tolerance of 0.7 degree. We also provided square and diagonal stub dimensions which enable us to check the tower leg positions for movement. This information was processed, checked, and delivered to the client within 24 hours of the initial survey, confirming the steel legs had been distorted due to the pressure exerted by the ever increasing spoil heap.

Following the second visit, the verticality survey was updated, and the collected scan data was processed. As well as a full point cloud model of the tower, the client was provided with a DGN comparison model containing the point cloud data and an accurate 3D tower model, illustrating that the tower legs/foundations closest to the spoil heap had been pushed inward; this information will be invaluable to the client for any proposed corrective works. The scan data can also be used to check individual members of the tower and any ancillary equipment mounted on the tower in or positioned close by.
