# CASE STUDY

## TOWER VERTICALITY, SCANNING & MONITORING

**Project:** Tower Verticality, Monitoring & Scanning  
**Location:** Tilbury, Essex  
**Year:** 2019  
**Duration:** 2 days

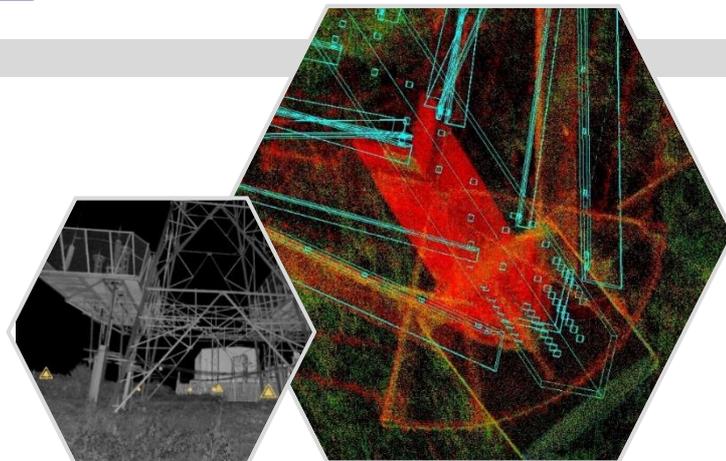
Using the survey data, we were able to extract the necessary information to prove that the tower's lean was within acceptable tolerance of 0.7 degree. We also provided square and diagonal stub dimensions which enable us to check the tower leg positions for movement. This information was processed, checked, and delivered to the client within 24 hours of the initial survey, confirming the steel legs had been distorted due to the pressure exerted by the ever increasing spoil heap.

Following the second visit, the verticality survey was updated, and the collected scan data was processed. As well as a full point cloud model of the tower, the client was provided with a DGN comparison model containing the point cloud data and an accurate 3D tower model, illustrating that the tower legs/foundations closest to the spoil heap had been pushed inward; this information will be invaluable to the client for any proposed corrective works. The scan data can also be used to check individual members of the tower and any ancillary equipment mounted on the tower in or positioned close by.
